# SLATE ROOFING MAINTENANCE & REPAIRS

## FAIRLINGTON GLEN CONDOMINIUMS

### ARLINGTON, VIRGINIA

**MAINTENANCE INVESTIGATION**  
**FAIRLINGTON GLEN CONDOMINIUM**  
**ARLINGTON, VIRGINIA 22206**

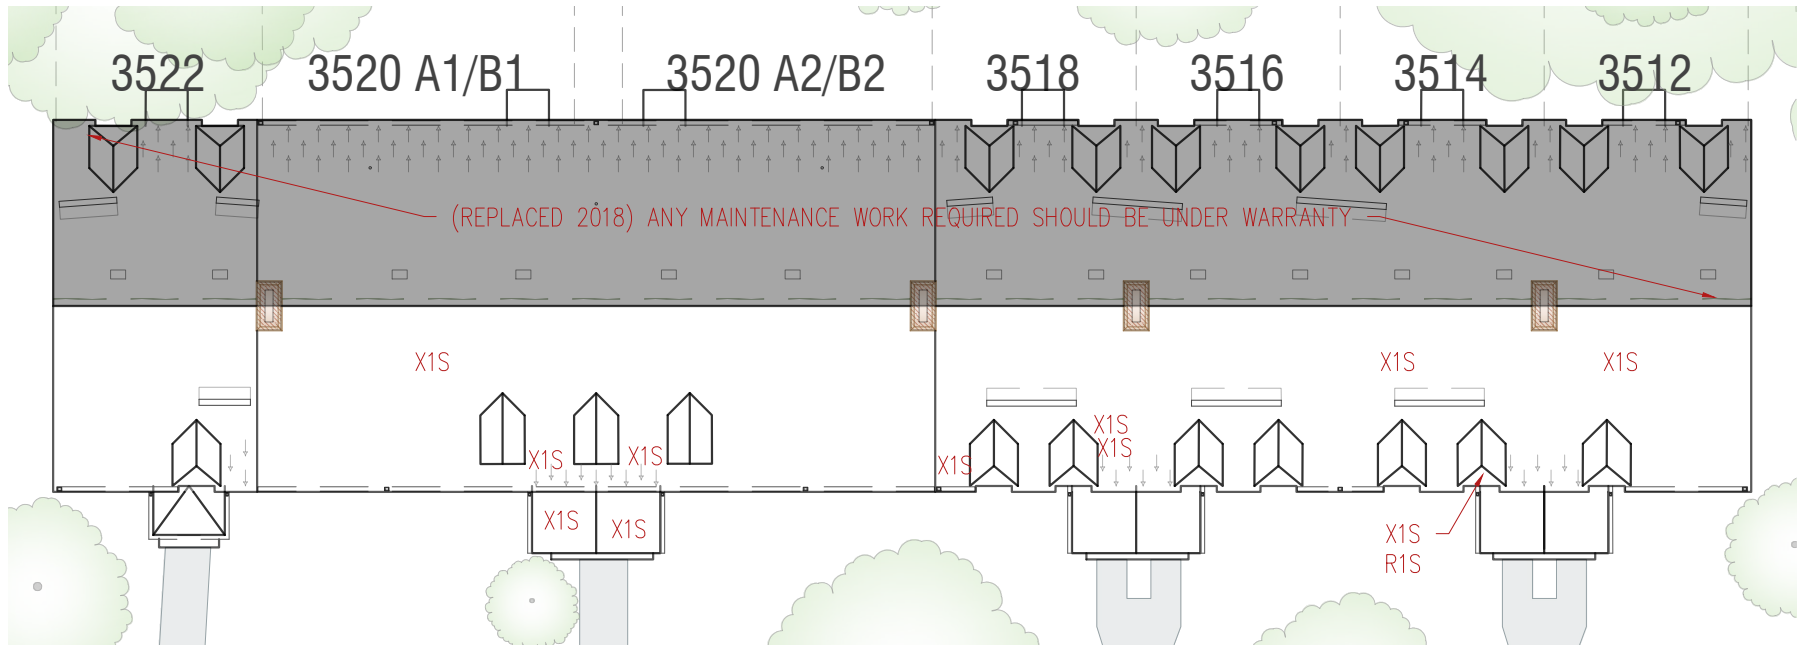
A-1.1

COMMENTS:
- FRONT REPLACED 1995 (VMT GREEN)
- REAR REPLACED 2018 (VMT GREEN)
- TRIM BACK BRANCHES FROM ROOF

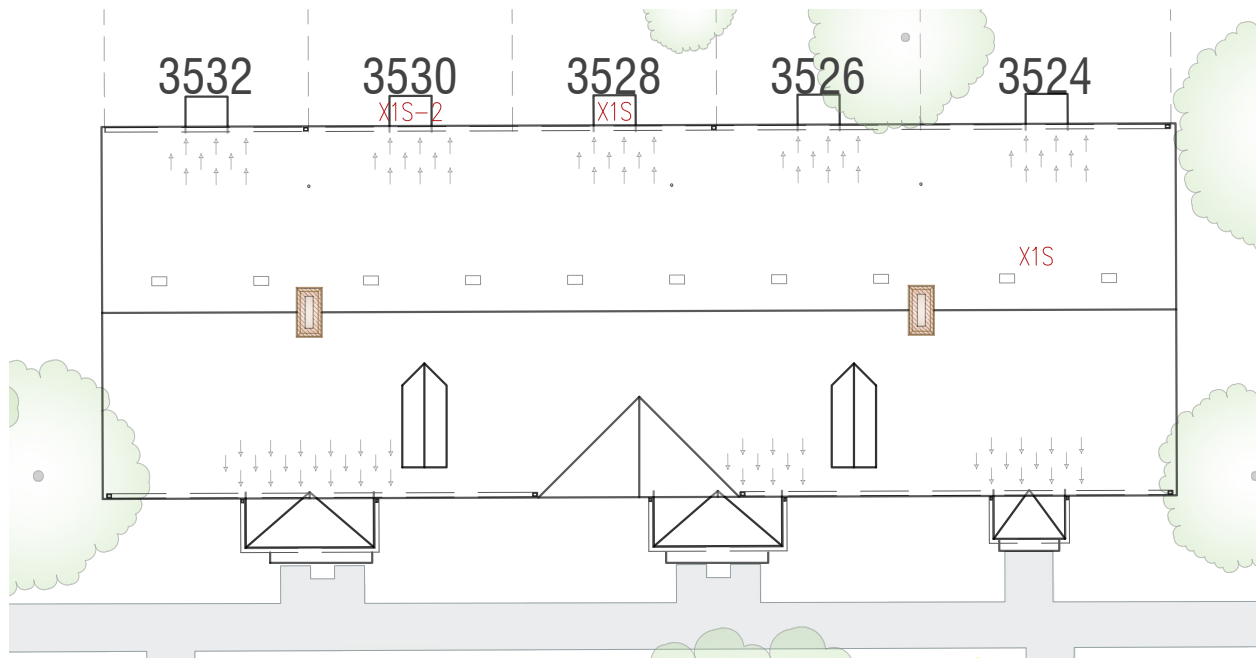
**A-1.2**

CODE:	DESCRIPTION:	CODE:	DESCRIPTION:	COMMENTS:
R1S	RESEAL EXPOSED NAIL HEAD	X2GU	REPLACE CANOPY ROOF GUTTER	- FRONT REPLACED 2010 (VRMT GREEN) - REAR REPLACED 2010 (VRMT GREEN) - TRIM BACK BRANCHES FROM ROOF
R2S	REFASTEN SLATE IN KEYWAY	X4GU	INSTALL NEW GUTTER STRAPS & REINF. ANGLES	
X1S	REPLACE SLATE SHINGLE	X6GU	REPLACE GUTTER END CLOSURE	
X2S	INSTALL COPPER BIB	C1DS	CLEAR CLOGGED DOWNSPOUT	
X3S	INSTALL COPPER STRIPPING	X3DS	REPLACE DOWNSPOUT	
X1SG	INSTALL NEW SNOW GUARDS	R1VP	PAINT VENT PIPE FLASHING	
R1GU	REFASTEN GUTTER	X1VP	REFLASH VENT PIPE	
X1GU	REPLACE MAIN ROOF GUTTER

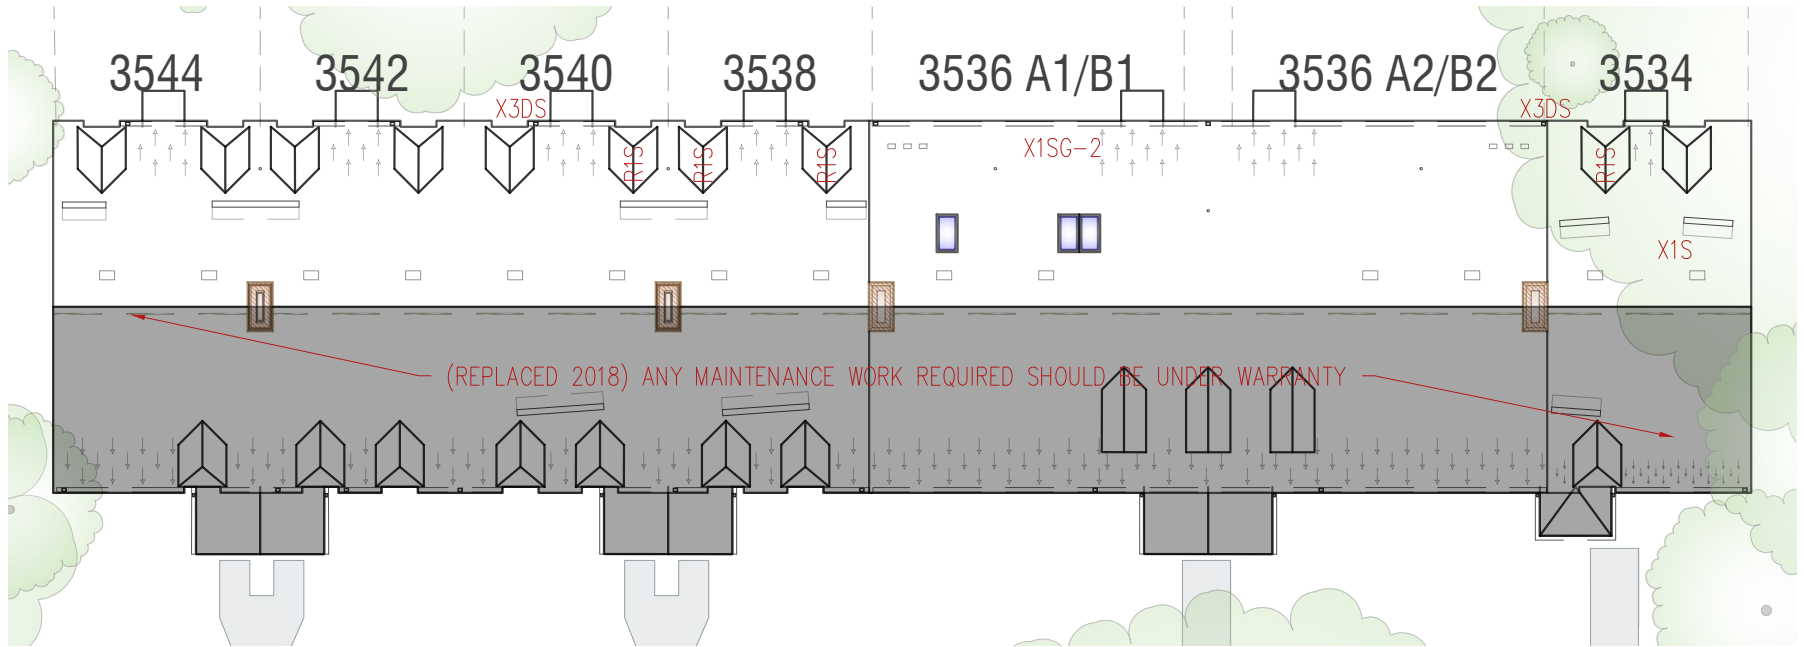
**A-1.3**

- FRONT REPLACED 2018 (VMT GREEN)
- REAR REPLACED 1998 (VMT GREEN)
- TRIM BACK BRANCHES FROM ROOF
- REPLACE TOP PART OF DOWNSPOUT WHERE CONNECTING TO THE GUTTER (X3DS)

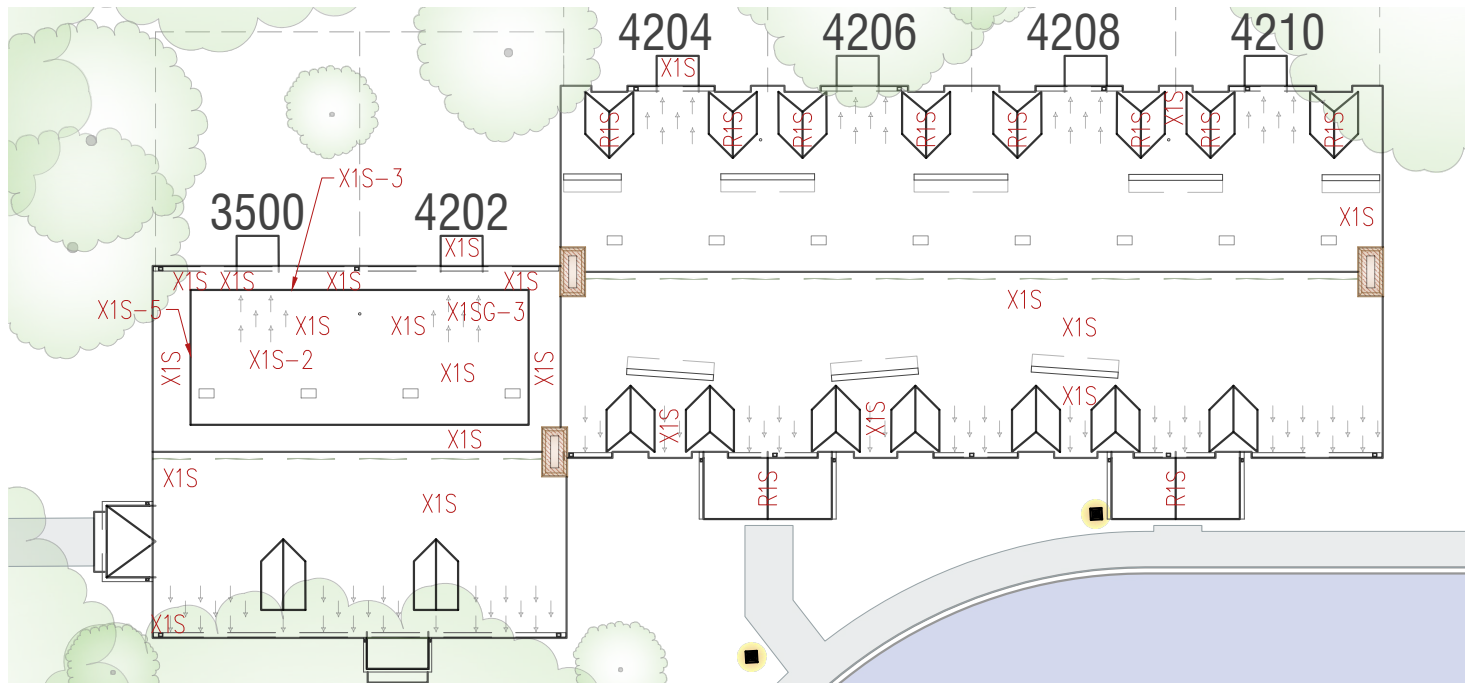
A-1.4

CODE:	DESCRIPTION:	CODE:	DESCRIPTION:	COMMENTS:
R1S	RESEAL EXPOSED NAIL HEAD	X2GU	REPLACE CANOPY ROOF GUTTER	<ul style="list-style-type: none"> <li>- FRONT REPLACED 2014 (VMT GREEN)</li> <li>- REAR REPLACED 2004 (VMT GREEN)</li> <li>- TRIM BACK BRANCHES FROM ROOF</li> </ul>
R2S	REFASTEN SLATE IN KEYWAY	X4GU	INSTALL NEW GUTTER STRAPS & REINF. ANGLES	
X1S	REPLACE SLATE SHINGLE	X6GU	REPLACE GUTTER END CLOSURE	
X2S	INSTALL COPPER BIB	C1DS	CLEAR CLOGGED DOWNSPOUT	
X3S	INSTALL COPPER STRIPPING	X3DS	REPLACE DOWNSPOUT	
X1SG	INSTALL NEW SNOW GUARDS	R1VP	PAINT VENT PIPE FLASHING	
R1GU	REFASTEN GUTTER	X1VP	REFLASH VENT PIPE	
X1GU	REPLACE MAIN ROOF GUTTER

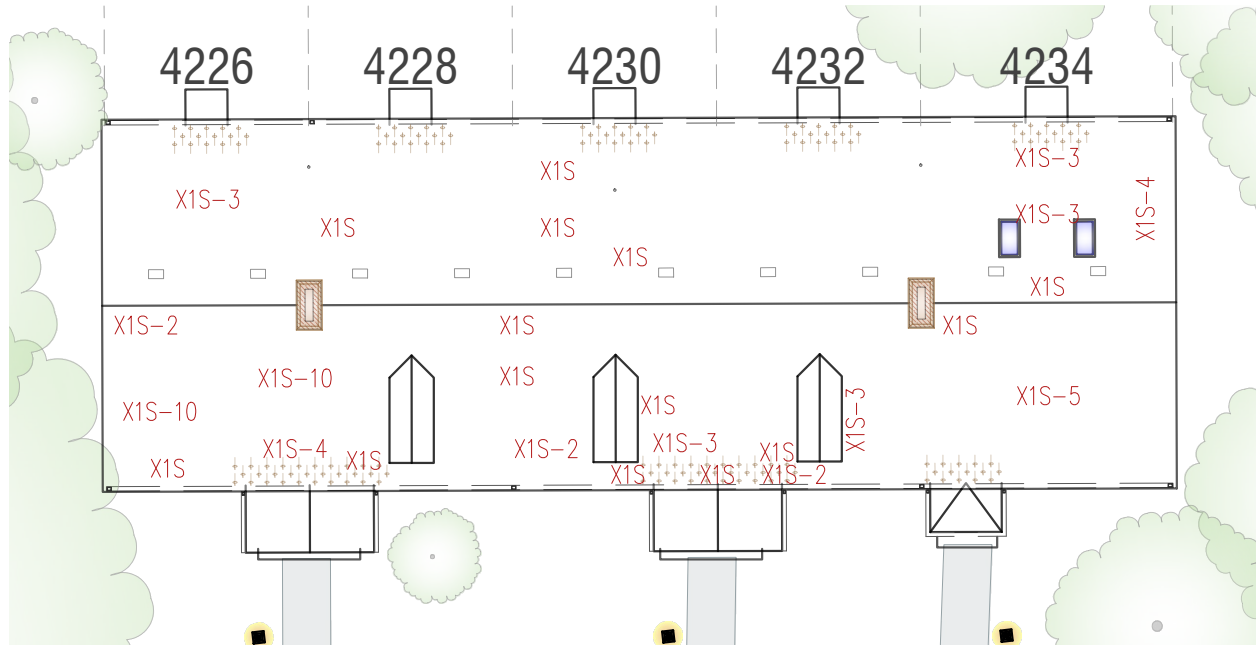
A-1.6

CODE:	DESCRIPTION:	CODE:	DESCRIPTION:	COMMENTS:
R1S	RESEAL EXPOSED NAIL HEAD	X2GU	REPLACE CANOPY ROOF GUTTER	<ul style="list-style-type: none"> <li>- ORIGINAL VERMONT SLATE AT FRONT</li> <li>- ORIGINAL VERMONT SLATE AT REAR</li> <li>- EXIST WIRE SNOWGUARDS</li> <li>- TRIM BACK BRANCHES FROM ROOF</li> </ul>
R2S	REFASTEN SLATE IN KEYWAY	X4GU	INSTALL NEW GUTTER STRAPS & REINF. ANGLES	
X1S	REPLACE SLATE SHINGLE	X6GU	REPLACE GUTTER END CLOSURE	
X2S	INSTALL COPPER BIB	C1DS	CLEAR CLOGGED DOWNSPOUT	
X3S	INSTALL COPPER STRIPPING	X3DS	REPLACE DOWNSPOUT	
X1SG	INSTALL NEW SNOW GUARDS	R1VP	PAINT VENT PIPE FLASHING	
R1GU	REFASTEN GUTTER	X1VP	REFLASH VENT PIPE	
X1GU	REPLACE MAIN ROOF GUTTER

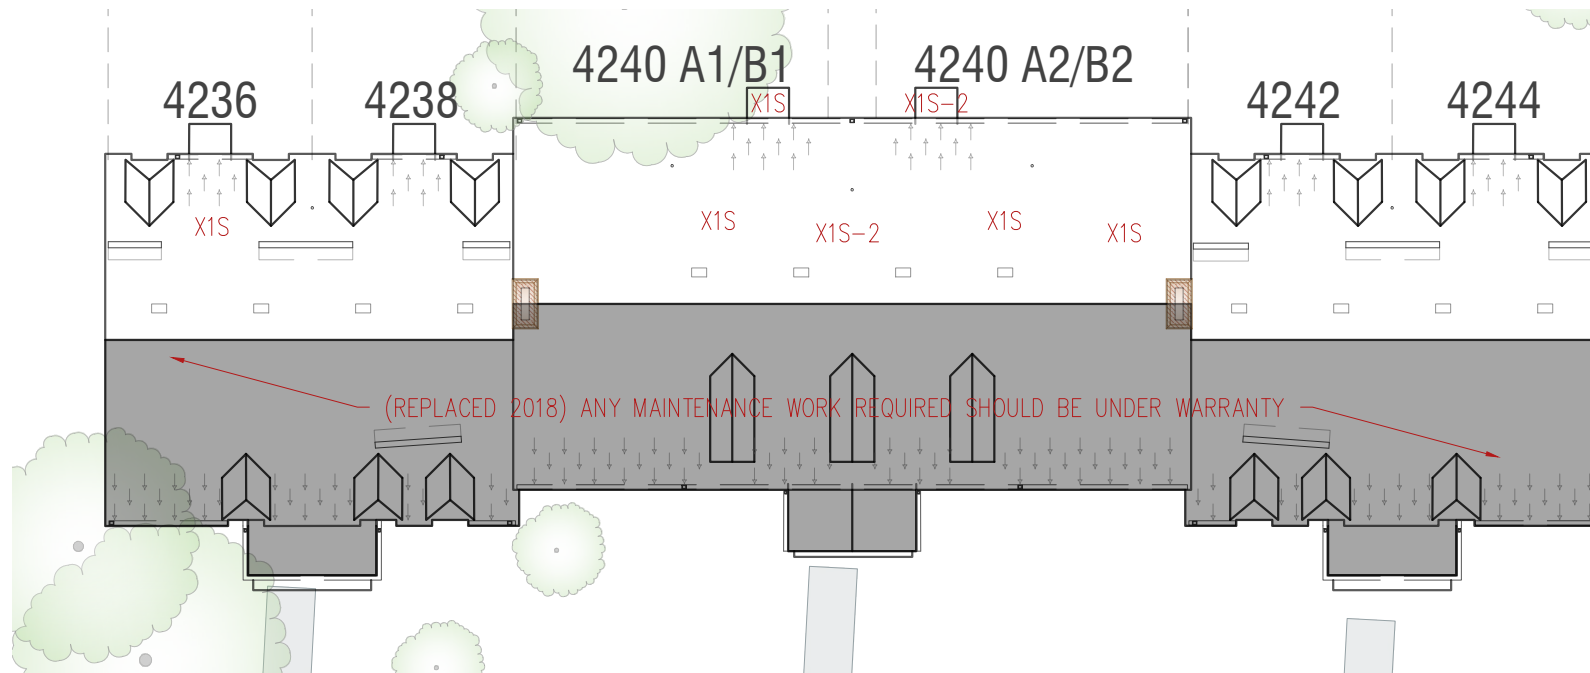
A-1.7

CODE:	DESCRIPTION:	CODE:	DESCRIPTION:	COMMENTS:
R1S	RESEAL EXPOSED NAIL HEAD	X2GU	REPLACE CANOPY ROOF GUTTER	<ul style="list-style-type: none"> <li>- FRONT REPLACED 2018 (VMT GREEN)</li> <li>- REAR REPLACED 1998 (VMT GREEN)</li> <li>- TRIM BACK BRANCHES FROM ROOF</li> </ul>
R2S	REFASTEN SLATE IN KEYWAY	X4GU	INSTALL NEW GUTTER STRAPS & REINF. ANGLES	
X1S	REPLACE SLATE SHINGLE	X6GU	REPLACE GUTTER END CLOSURE	
X2S	INSTALL COPPER BIB	C1DS	CLEAR CLOGGED DOWNSPOUT	
X3S	INSTALL COPPER STRIPPING	X3DS	REPLACE DOWNSPOUT	
X1SG	INSTALL NEW SNOW GUARDS	R1VP	PAINT VENT PIPE FLASHING	
R1GU	REFASTEN GUTTER	X1VP	REFLASH VENT PIPE	
X1GU	REPLACE MAIN ROOF GUTTER

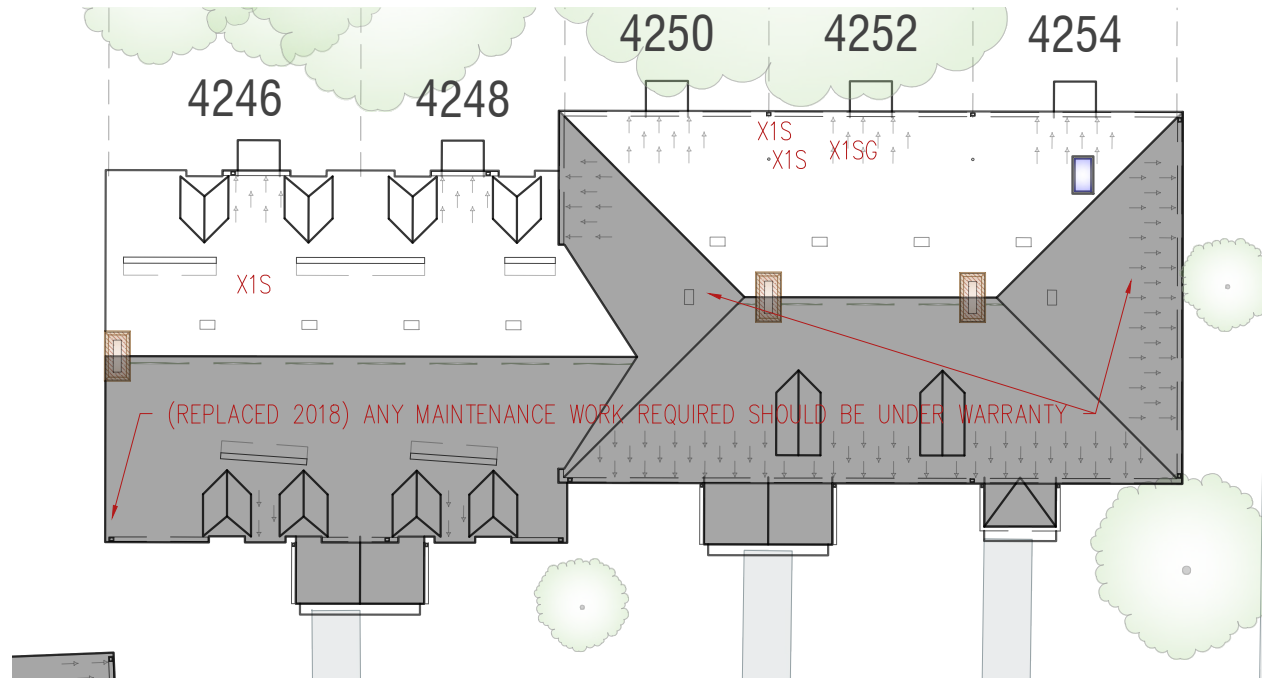
A-1.8

CODE:	DESCRIPTION:	CODE:	DESCRIPTION:	COMMENTS:
R1S	RESEAL EXPOSED NAIL HEAD	X2GU	REPLACE CANOPY ROOF GUTTER	- FRONT REPLACED 2018 (VMT GREEN) - REAR REPLACED 2007 (VMT GREEN)
R2S	REFASTEN SLATE IN KEYWAY	X4GU	INSTALL NEW GUTTER STRAPS & REINF. ANGLES	
X1S	REPLACE SLATE SHINGLE	X6GU	REPLACE GUTTER END CLOSURE	
X2S	INSTALL COPPER BIB	C1DS	CLEAR CLOGGED DOWNSPOUT	
X3S	INSTALL COPPER STRIPPING	X3DS	REPLACE DOWNSPOUT	
X1SG	INSTALL NEW SNOW GUARDS	R1VP	PAINT VENT PIPE FLASHING	
R1GU	REFASTEN GUTTER	X1VP	REFLASH VENT PIPE	
X1GU	REPLACE MAIN ROOF GUTTER

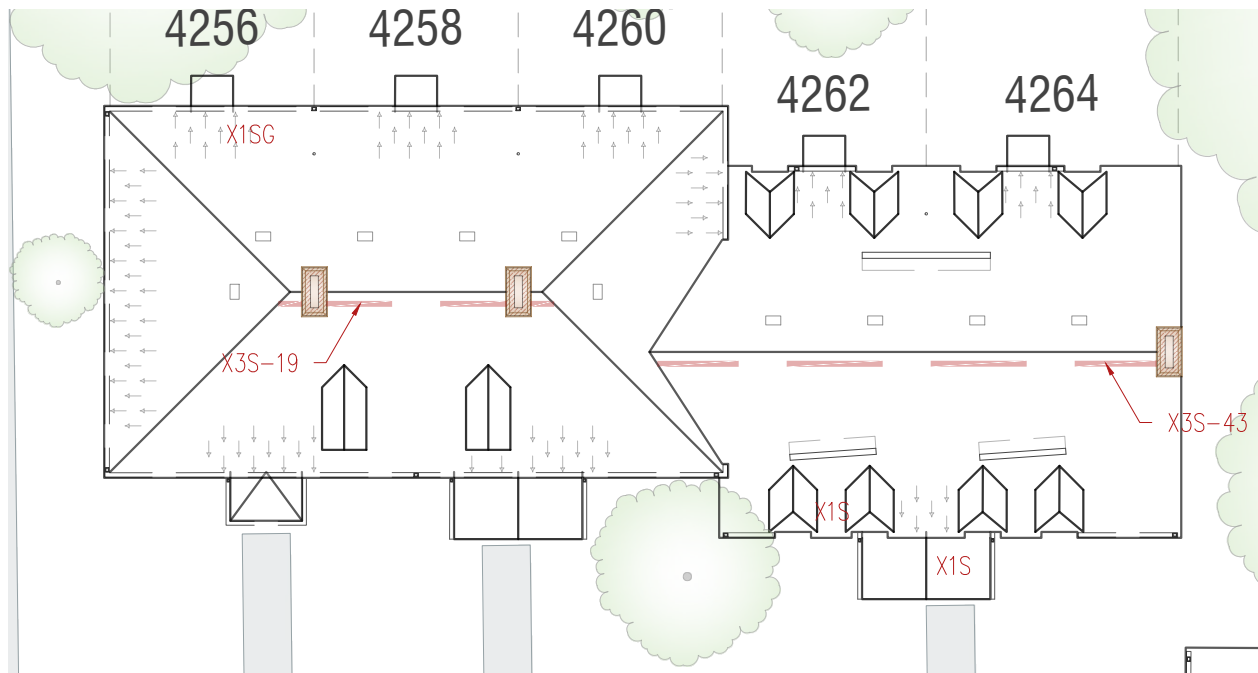
A-1.9

CODE:	DESCRIPTION:	CODE:	DESCRIPTION:	COMMENTS:
R1S	RESEAL EXPOSED NAIL HEAD	X2GU	REPLACE CANOPY ROOF GUTTER	- FRONT REPLACED 2007 (VMT GREEN) - REAR REPLACED 2007 (VMT GREEN) - BRICK MASONRY ABOVE FRONT ENTRY OF UNITS 4262/4264 IS DIRTY
R2S	REFASTEN SLATE IN KEYWAY	X4GU	INSTALL NEW GUTTER STRAPS & REINF. ANGLES	
X1S	REPLACE SLATE SHINGLE	X6GU	REPLACE GUTTER END CLOSURE	
X2S	INSTALL COPPER BIB	C1DS	CLEAR CLOGGED DOWNSPOUT	
X3S	INSTALL COPPER STRIPPING	X3DS	REPLACE DOWNSPOUT	
X1SG	INSTALL NEW SNOW GUARDS	R1VP	PAINT VENT PIPE FLASHING	
R1GU	REFASTEN GUTTER	X1VP	REFLASH VENT PIPE	
X1GU	REPLACE MAIN ROOF GUTTER

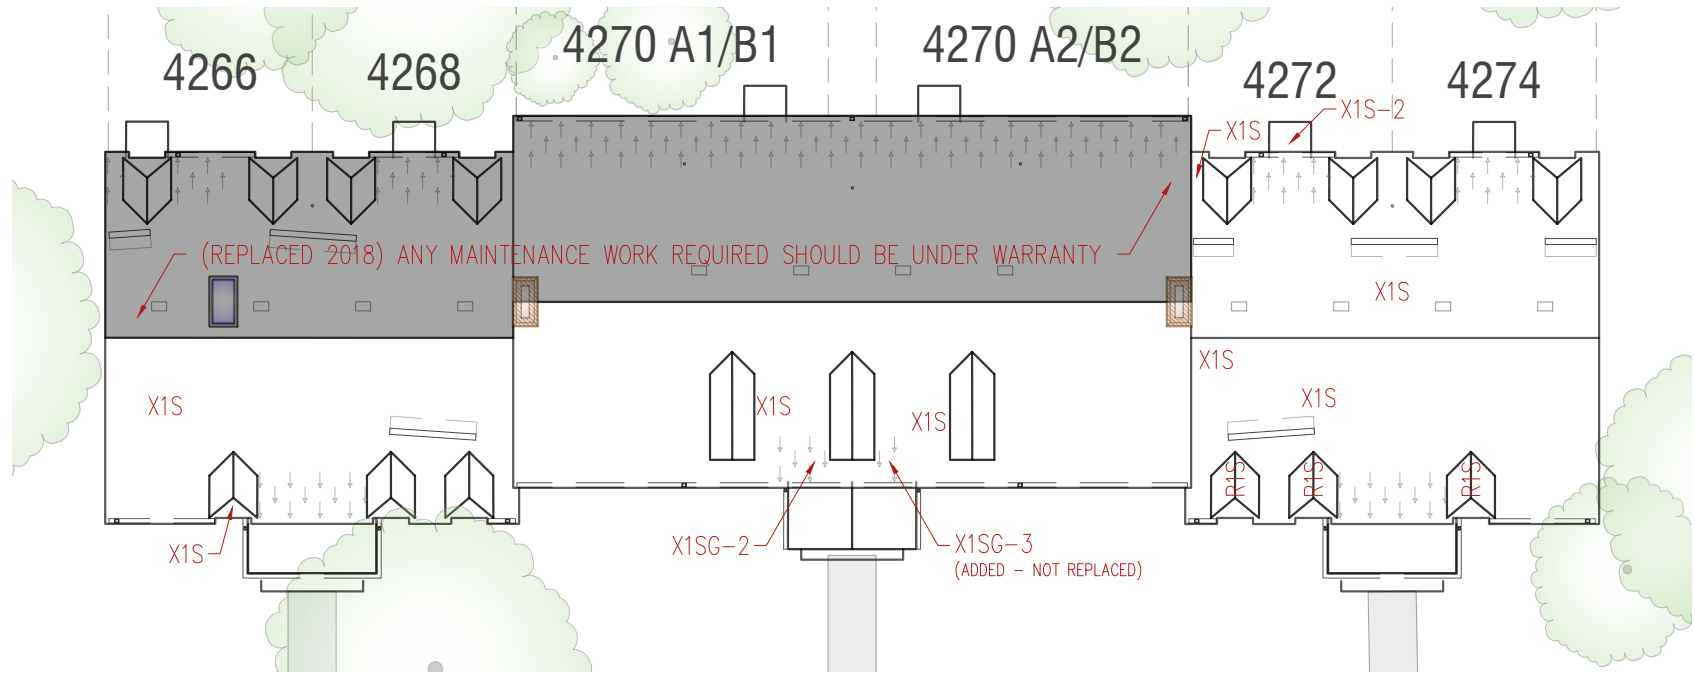
A-1.10  
 11 OF 16

CODE:	DESCRIPTION:	CODE:	DESCRIPTION:	COMMENTS:
R1S	RESEAL EXPOSED NAIL HEAD	X2GU	REPLACE CANOPY ROOF GUTTER	- FRONT REPLACED 1999 (VMT GREEN) - REAR 4266-70 RPLCD 2018 (VMT GRN) - REAR 4272-74 RPLCD 1999 (VMT GRN) - TRIM BACK BRANCHES FROM ROOF
R2S	REFASTEN SLATE IN KEYWAY	X4GU	INSTALL NEW GUTTER STRAPS & REINF. ANGLES	
X1S	REPLACE SLATE SHINGLE	X6GU	REPLACE GUTTER END CLOSURE	
X2S	INSTALL COPPER BIB	C1DS	CLEAR CLOGGED DOWNSPOUT	
X3S	INSTALL COPPER STRIPPING	X3DS	REPLACE DOWNSPOUT	
X1SG	INSTALL NEW SNOW GUARDS	R1VP	PAINT VENT PIPE FLASHING	
R1GU	REFASTEN GUTTER	X1VP	REFLASH VENT PIPE	
X1GU	REPLACE MAIN ROOF GUTTER

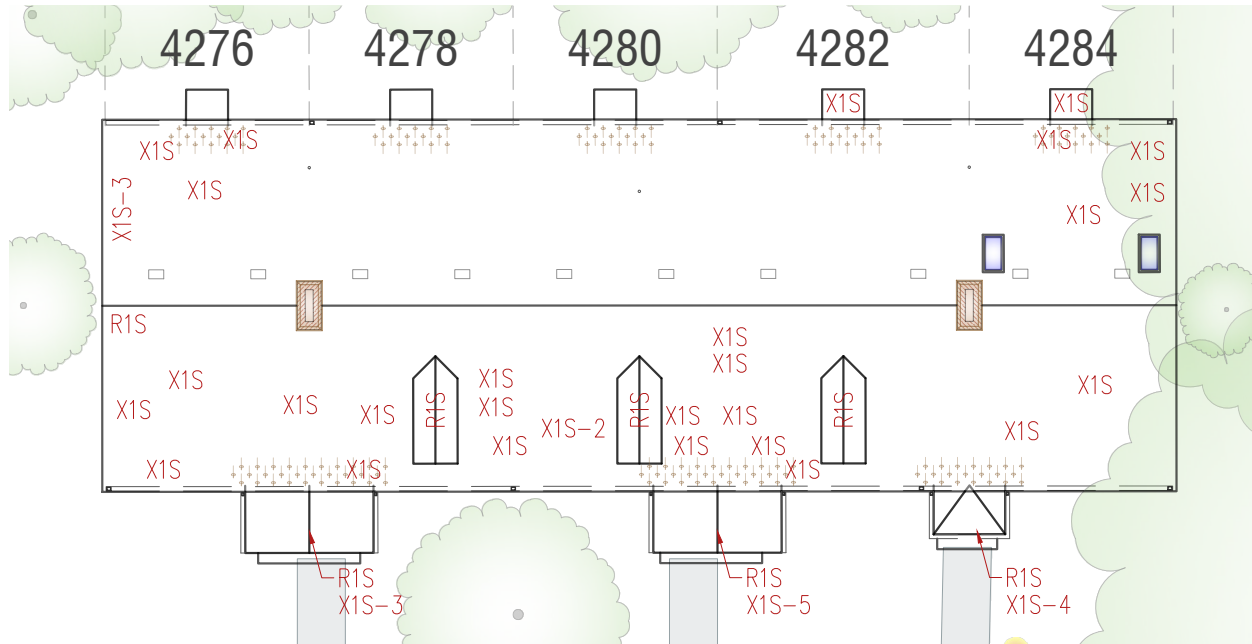
A-1.11

CODE:	DESCRIPTION:	CODE:	DESCRIPTION:	COMMENTS:
R1S	RESEAL EXPOSED NAIL HEAD	X2GU	REPLACE CANOPY ROOF GUTTER	<ul style="list-style-type: none"> <li>- ORIGINAL VERMONT SLATE AT FRONT</li> <li>- ORIGINAL VERMONT SLATE AT REAR</li> <li>- EXIST WIRE SNOWGUARDS</li> <li>- TRIM BACK BRANCHES FROM ROOF</li> </ul>
R2S	REFASTEN SLATE IN KEYWAY	X4GU	INSTALL NEW GUTTER STRAPS & REINF. ANGLES	
X1S	REPLACE SLATE SHINGLE	X6GU	REPLACE GUTTER END CLOSURE	
X2S	INSTALL COPPER BIB	C1DS	CLEAR CLOGGED DOWNSPOUT	
X3S	INSTALL COPPER STRIPPING	X3DS	REPLACE DOWNSPOUT	
X1SG	INSTALL NEW SNOW GUARDS	R1VP	PAINT VENT PIPE FLASHING	
R1GU	REFASTEN GUTTER	X1VP	REFLASH VENT PIPE	
X1GU	REPLACE MAIN ROOF GUTTER

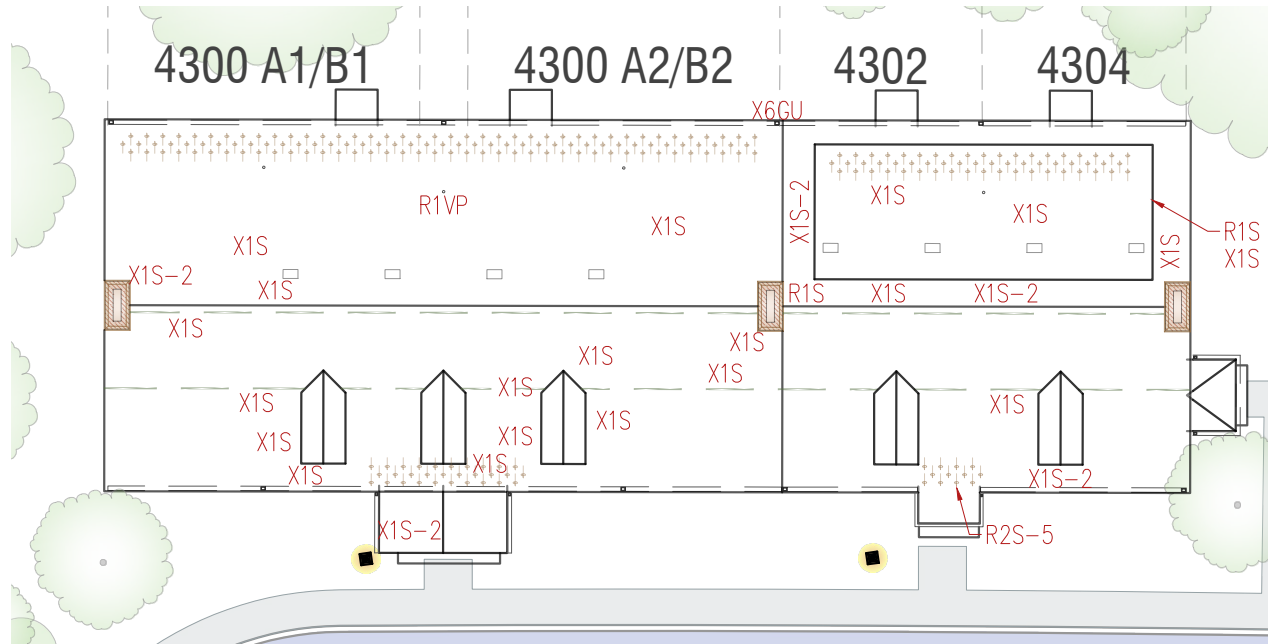
**A-1.12**

- ORIGINAL VERMONT SLATE AT FRONT
- ORIGINAL VERMONT SLATE AT REAR
- EXIST WIRE SNOWGUARDS
- ASPHALT SHINGLES AT REAR CANOPIES
- REPLACE GUTTER END CLOSURE (X6GU) AT EAST END OF UNIT 4300 A2/B2

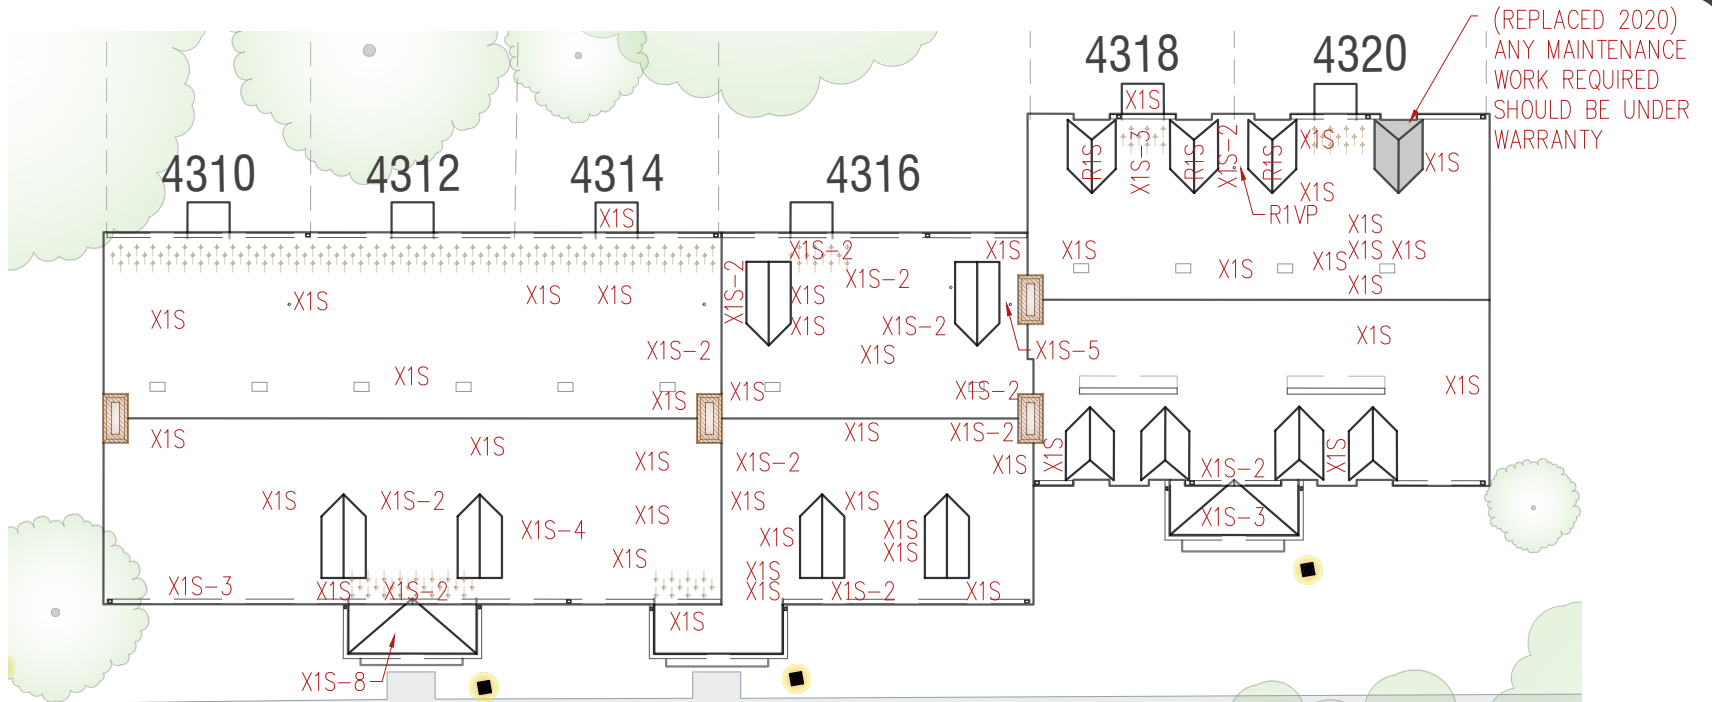
A-1.13  
 14 OF 16

CODE:	DESCRIPTION:	CODE:	DESCRIPTION:	COMMENTS:
R1S	RESEAL EXPOSED NAIL HEAD	X2GU	REPLACE CANOPY ROOF GUTTER	<ul style="list-style-type: none"> <li>- ORIGINAL VERMONT SLATE AT FRONT</li> <li>- ORIGINAL VERMONT SLATE AT REAR</li> <li>- EXIST WIRE SNOWGUARDS</li> <li>- UNIT 4320 REAR EAST DORMER REPLACED WITH NEW UNDERLAYMENT MATERIALS AND NEW &amp; SALVAGED SLATE AS PART OF 2020 M&amp;R PROJECT</li> <li>- ASPHALT SHINGLES AT UNIT 4316 REAR CANOPY</li> </ul>
R2S	REFASTEN SLATE IN KEYWAY	X4GU	INSTALL NEW GUTTER STRAPS & REINF. ANGLES	
X1S	REPLACE SLATE SHINGLE	X6GU	REPLACE GUTTER END CLOSURE	
X2S	INSTALL COPPER BIB	C1DS	CLEAR CLOGGED DOWNSPOUT	
X3S	INSTALL COPPER STRIPPING	X3DS	REPLACE DOWNSPOUT	
X1SG	INSTALL NEW SNOW GUARDS	R1VP	PAINT VENT PIPE FLASHING	
R1GU	REFASTEN GUTTER	X1VP	REFLASH VENT PIPE	
X1GU	REPLACE MAIN ROOF GUTTER
