**RESTORATION
ENGINEERING, INC.**

2023 REPLACEMENT RESERVE STUDY

FAIRLINGTON GLEN CONDOMINIUM

Arlington, Virginia

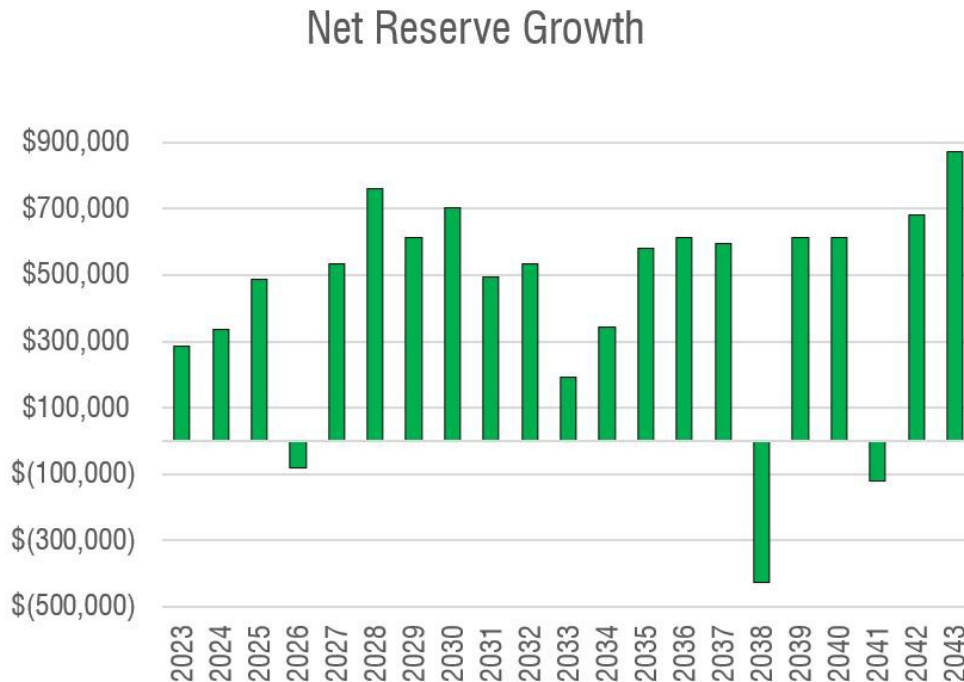
Meanwhile, the Glen’s replacement reserves grow at a rate exceeding both the rate of depreciation and expenditure. Starting from a base of \$681,000 in 2025, reserve contributions grow at 2.65% annually, and also earn after-tax interest that is contributed back to the reserve balance. The combination of positive reserve growth net of spending plus interest on reserves causes reserves to build up steadily over time as demonstrated in the bar chart below:

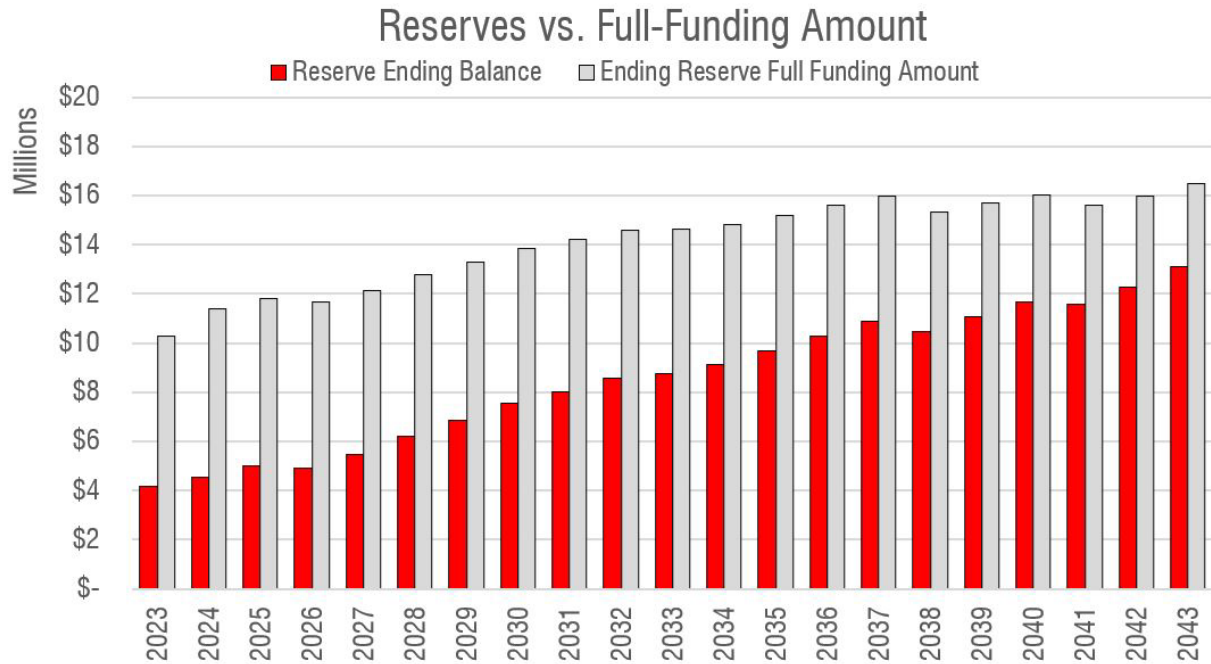
Thus, both accumulated depreciation and the replacement reserves grow steadily over time, but the reserves grow faster, causing the funding ratio to rise as demonstrated in the chart below:

Under these assumptions, Fairlington Glen’s funding ratio will rise from 40.8% in 2023 to 48.66% in 2028, 59.85% in 2033, and 79.56% by 2043.

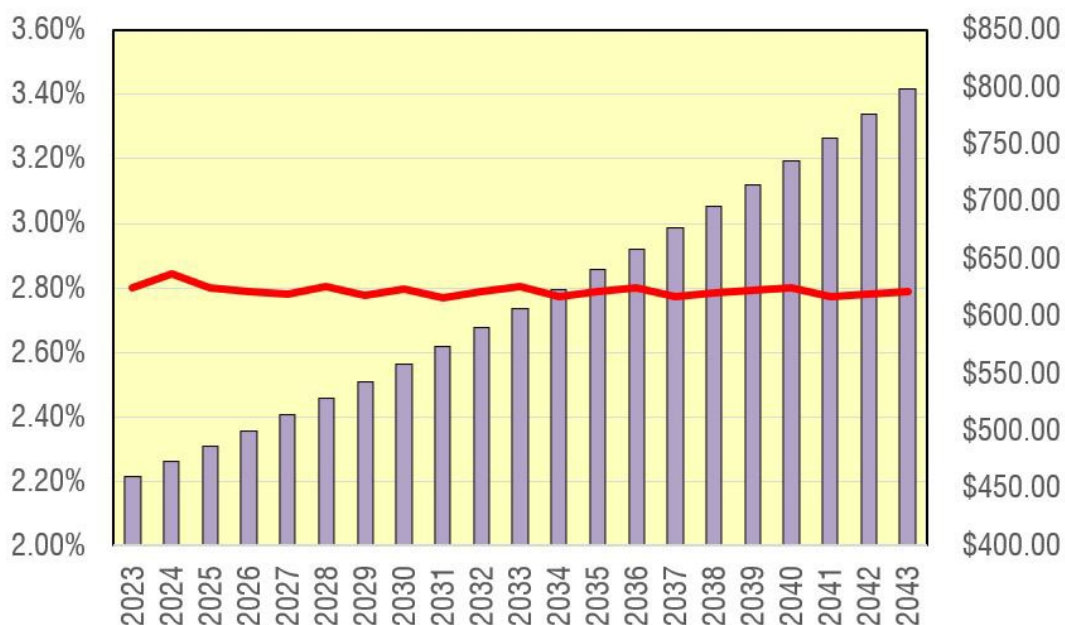
**Condo Fee Growth Rate +
Inside Clarendon Unit Projected Fees**

In this model, condominium fees are treated as a function of cost growth, and are simply an output of total costs. Since all input costs are tied to the assumed 2.55% inflation rate, condo fees increase at a slightly higher rate (2.8%). In actual practice, future inflation rates will vary each year and dictate the amount and volatility of condo fee increases that are necessary to keep pace with the Glen’s rising costs.

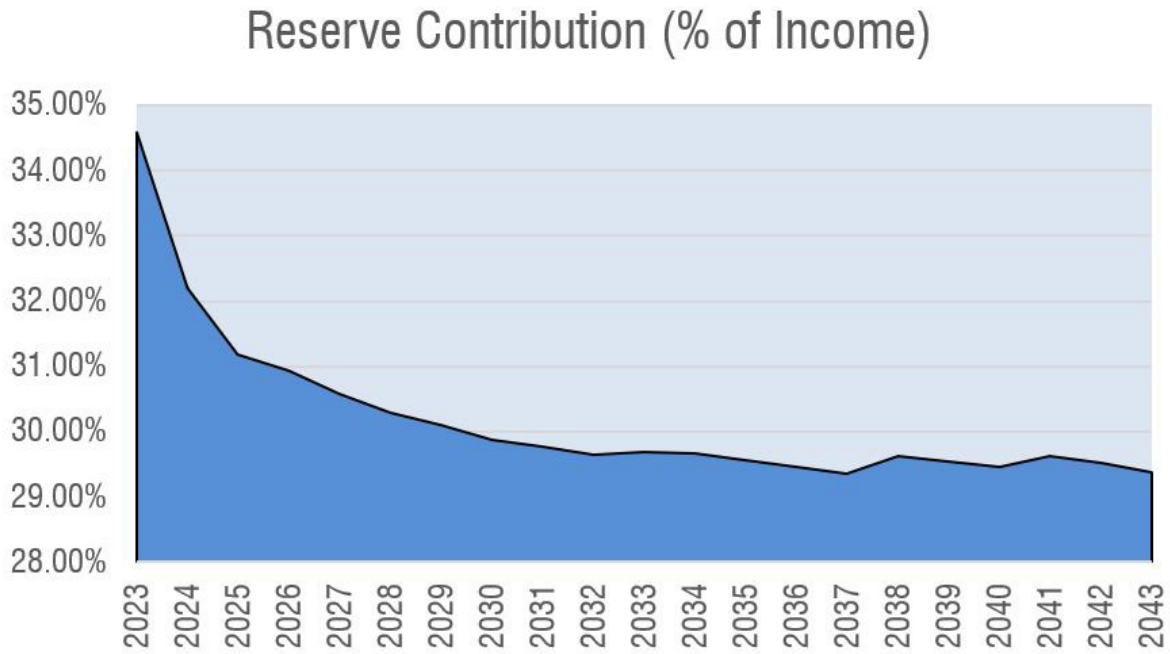
In the projection, the percentage of condo fees consumed by reserve contributions will remain relatively stable (between 29.0 and 30.0%) for the foreseeable future:
